**WL-TR-97-4054**

**PROCEEDINGS OF THE 1996 USAF  
AIRCRAFT STRUCTURAL INTEGRITY  
PROGRAM CONFERENCE**

**USAF Aircraft Structural Integrity Program Conference  
Hyatt Regency San Antonio  
San Antonio, Texas**

Economic Life Evaluation of the T-38-29 Wing .....	3
<i>H. Burnside and W. Wang</i>	
C-141 Systems and Structural Assessment Program .....	31
<i>H. Huggins, G. Weitz and R. Alford</i>	
Aging Aircraft Structures Database .....	63
<i>R. Perez and M. Van Dernoot</i>	
An Overview of the Wright Laboratory Structural Integrity of Aging Aircraft Core Area .....	85
<i>M. Zeigler, Capt J. Denney, C. Paul and L. Hutsell</i>	
Aging Aircraft Management - A Practical Analytical Approach for Effective Sustainment .....	109
<i>J. Cochran and R. Alford</i>	
F117-PW-100 Tailored ENSIP for Five Peacetime C-17 Missions .....	127
<i>S. Patel</i>	
ASIP and the Air Force Aging Aircraft Fleet .....	155
<i>R.N. Hadcock</i>

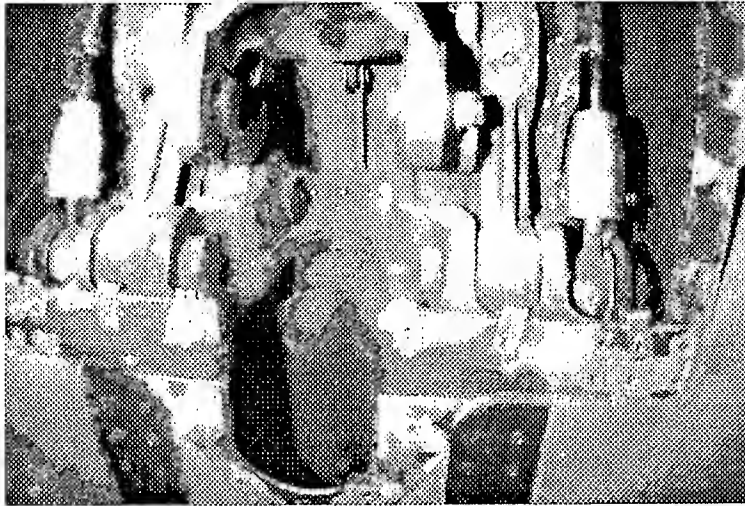
## System Discrepancy

This photo shows where a jackscrew has cut into a closure fitting inside the flap. This situation occurs when the flap carriage is mis-located.

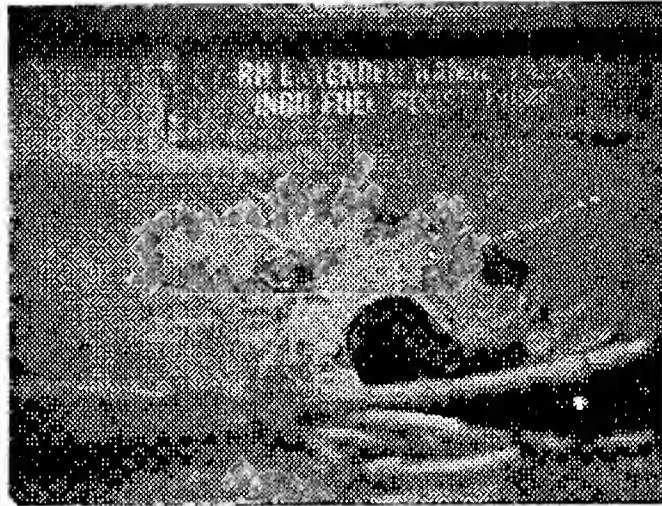
## System Check

A potentially serious area is where the wire for the fuel boost pump connector passes through the rear beam of the wing.

This photo is shot from the aft side of the wing rear beam. The connection is made within the wing box and is sealed by a housing. If the housing leaks and the hole is filled with sealant, fuel will be trapped at the connection. The hole should be clear of sealant as shown above.

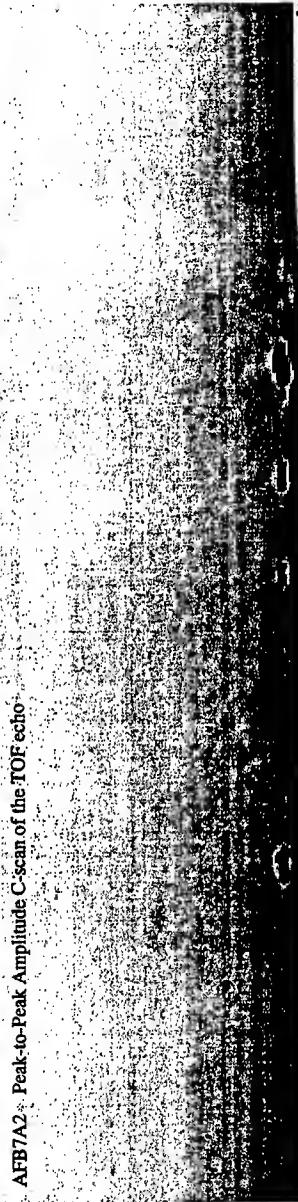
AFB-7 Laser Processed Engine Blade Specimen. Ti-6Al-4V Material. 50MHz, 0.5" Focused Transducer, 3-5-96 WL/MILLP

AFB7A2 Peak-to-Peak Amplitude C-scan of the TOF echo

- ◆ **As-received and LSP test samples, and fan blade which had been LSP'd were C-Scanned for flaws**
- ◆ **LSP sample was found to contain delaminations at the mid-plane of the thickness**
  - **The as-received specimen had none**
  - **Because of the curvature in the blade, proper inspection was impossible**

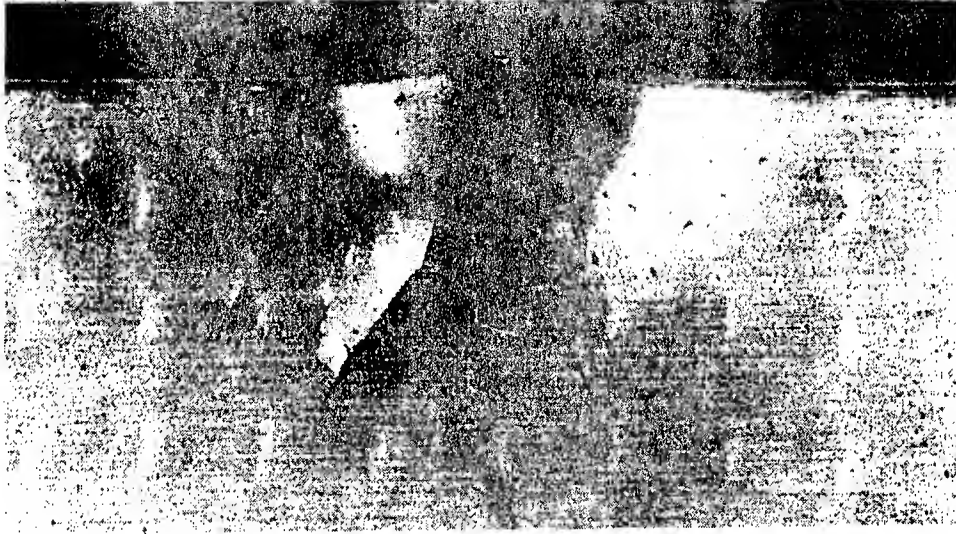
## TORSIONAL TEST OF LSP'D BLADE WITH NOTCH

Staircase test -  $10^7$  cycles

- Runout @ 20 ksida
- Failure @ 30 ksida

- Runout @ 200ksida
- Crack grew to 0.44" long and stopped growing
- Total crack length is 0.69" including damage

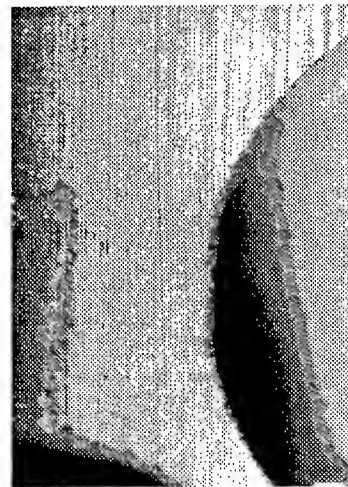
**Figure 6**  
**No Shear Tears - Sleeve**  
**Ridge 90° to Extrusion Grain**  
**Direction and Loading**

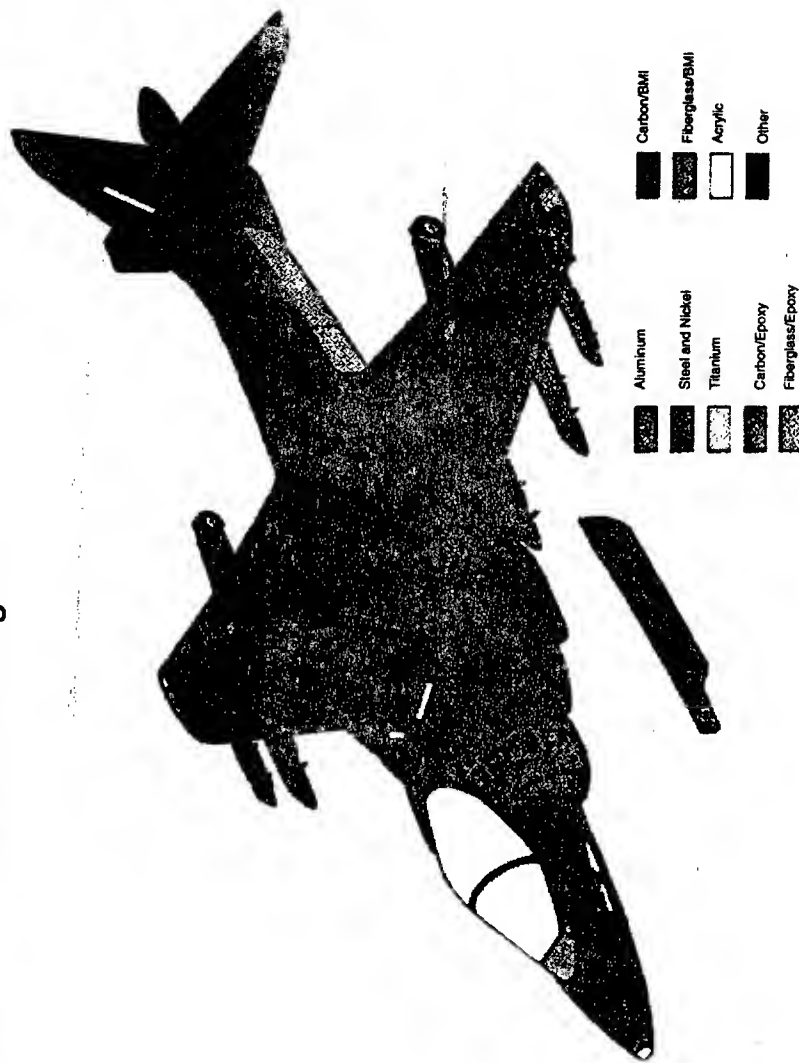
## AV-8B Material Usage

- The Structure of the Harrier Is a Combination of Carbon/Epoxy Composites and Metal.
- The AV-8B Is 26% Composite Materials.

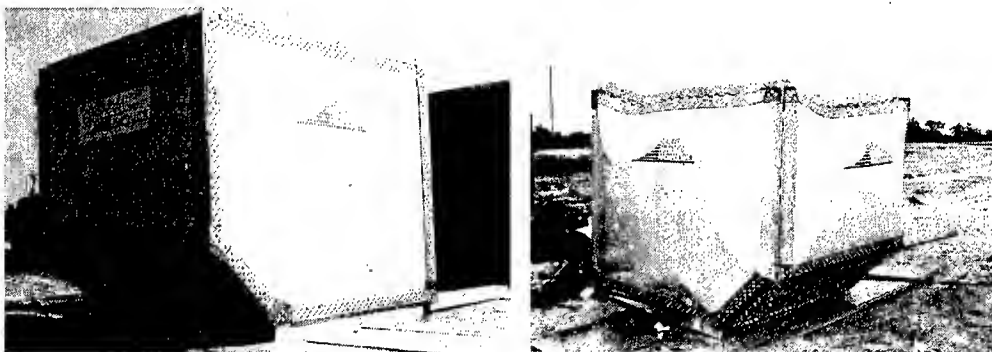
Fig. 1 GLARE® ECOS<sup>3</sup> before and after FAA-conducted explosive testing (courtesy Galaxy Scientific Co.)

The higher impact performance of GLARE® makes it an attractive material for impact prone areas like the cockpit crown, front bulkheads, leading edges, flaps, undercarriage doors and cargo floors. Its impact capabilities together with its flame resistant characteristics makes it suitable for cargo linings as well as "blast resistant" containers. Up to this moment a GLARE® container built by Galaxy Scientific Co.<sup>[4]</sup> is the only container which meets the blast and fire requirements of the FAA (Fig. 1).
